SOLID WASTE RECEIVER

Status Report  
of the  
Receivership for the Government of Guam  
Guam Solid Waste Authority  
Pursuant to the Order of the  
United States District Court of Guam

Presented by  
Gershman, Brickner & Bratton, Inc.  
December 16, 2022

1. Ordot Dump Post-Closure Facility  
Leachate and Seeps Investigation

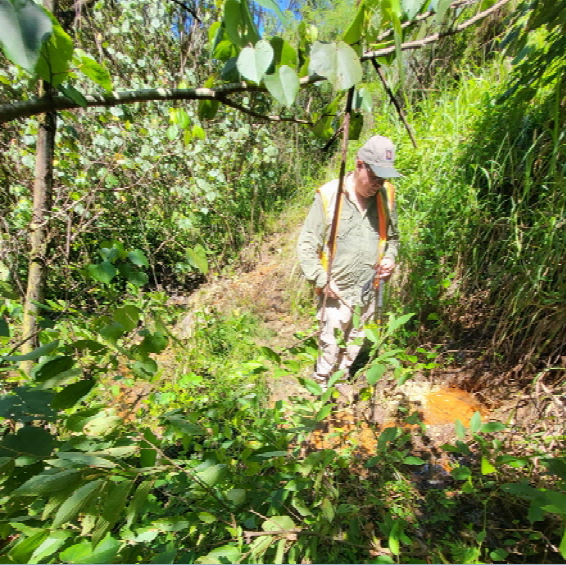
- West Side Reconnaissance
  - Approximately 700 ft of the West perimeter road embankment along the combined length of the Western Channel Relocated Stream alignment (approx. 450 ft) and the existing Western Channel was investigated for seeps
  - An area approximately 20 feet long along west side perimeter road embankment toe of slope is a seepage area. Not previously located – at the toe of slope of road embankment.

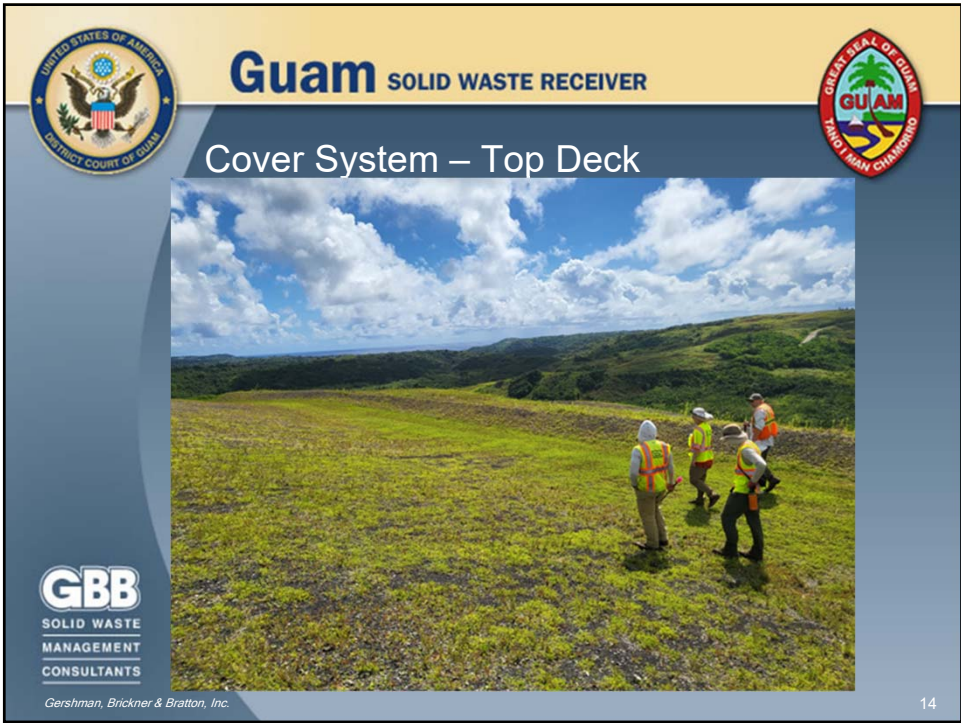
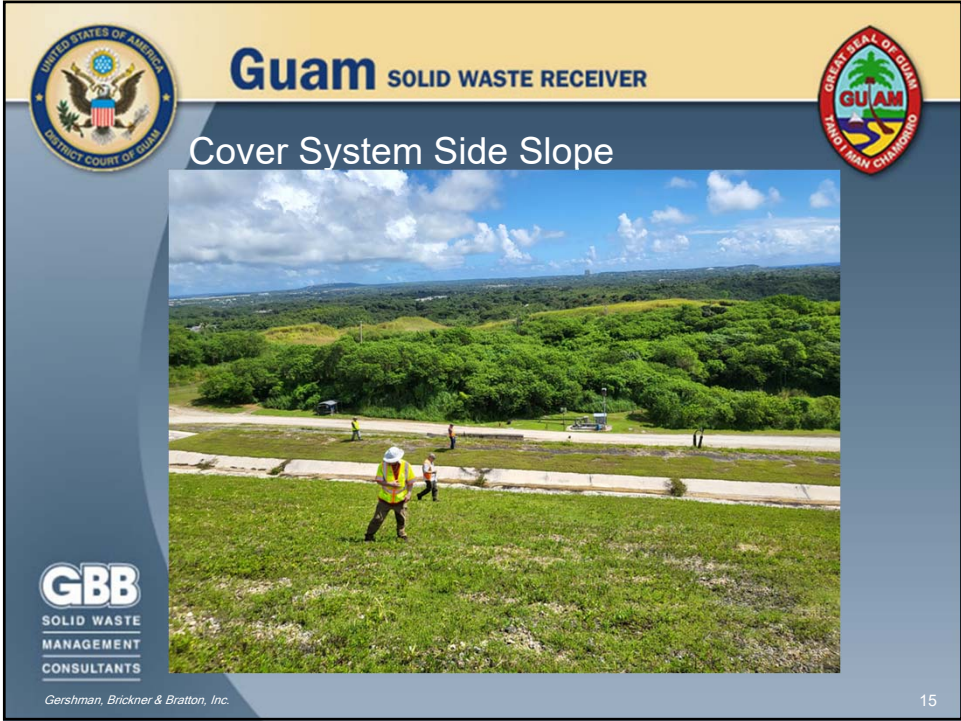
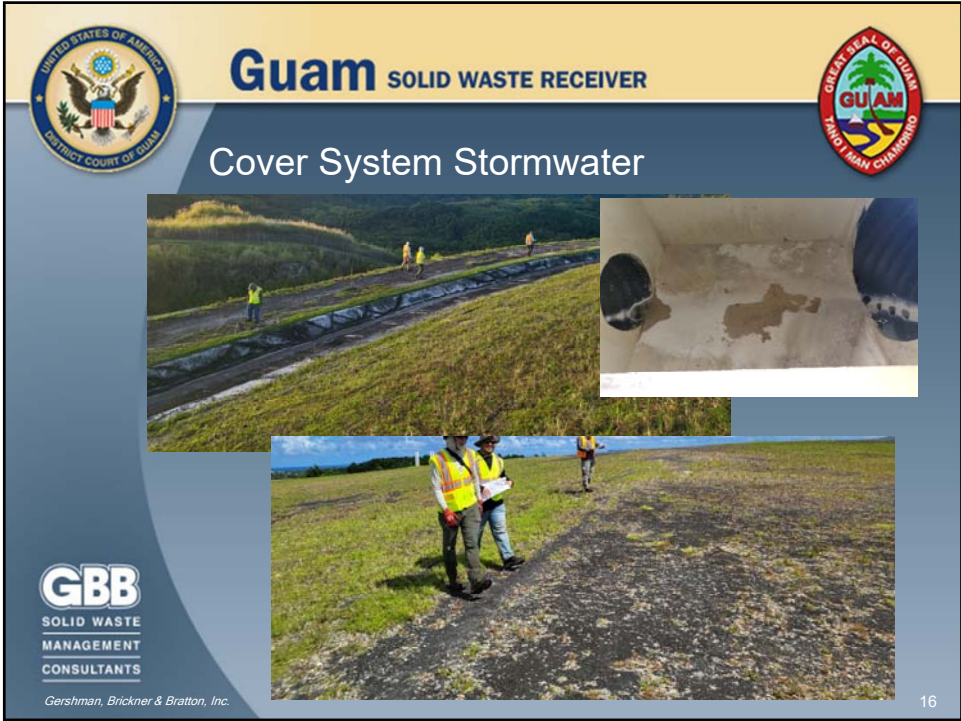
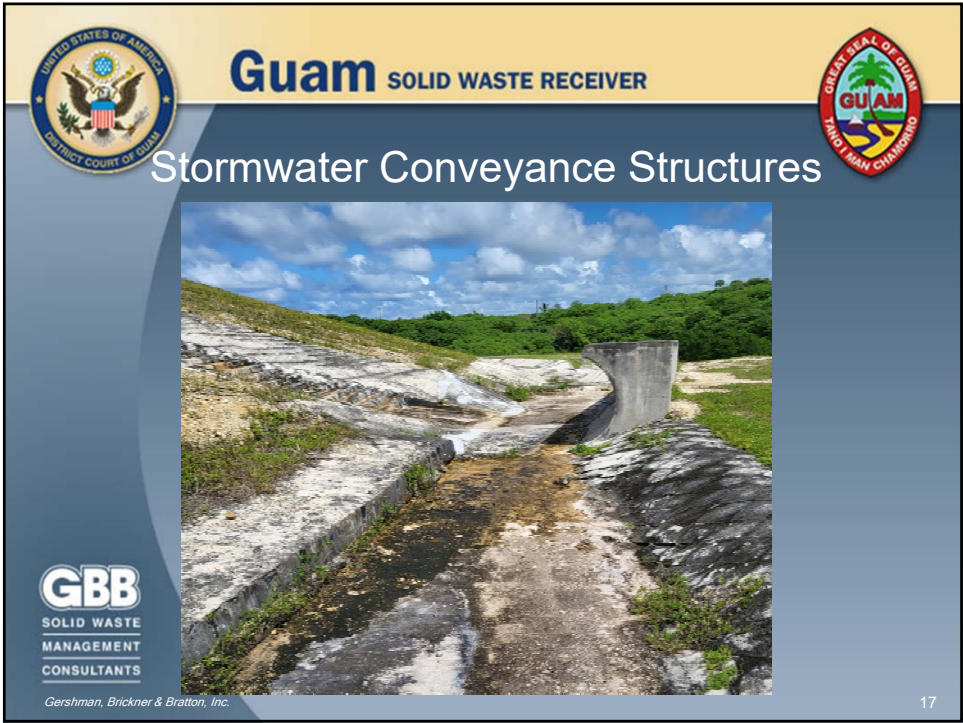
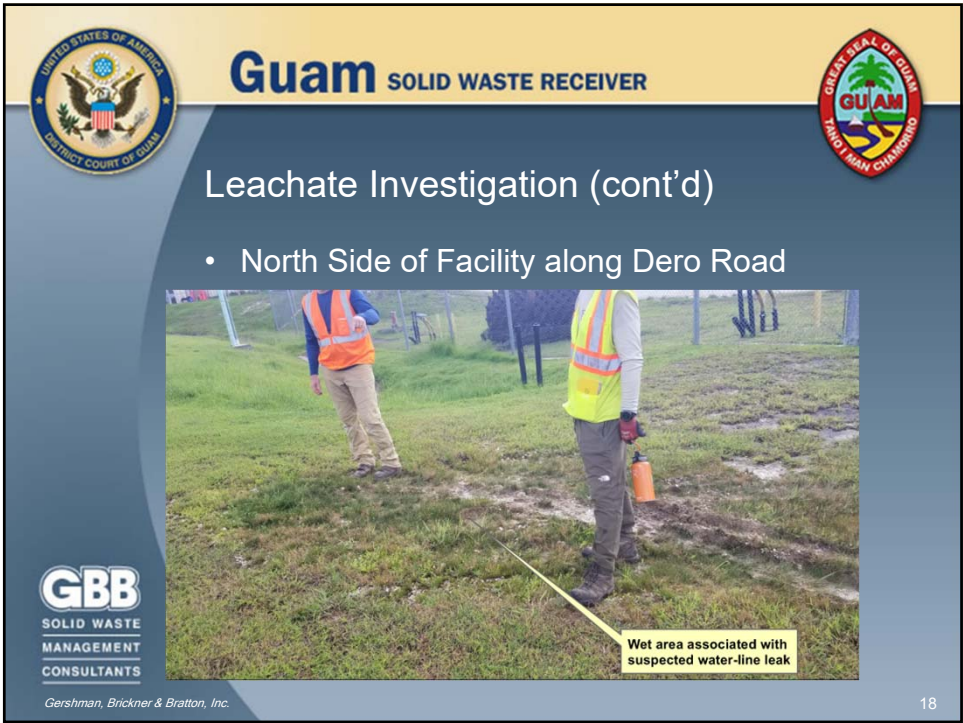
- Cover System Leachate Reconnaissance
  - Conduct a methodic and systematic walk of the cover system
    - Working from top to bottom cover all slopes and benches
    - Looking for abnormalities that could constitute a location where large quantities of stormwater can leak into the cover
    - No such abnormalities were found
  - Also Inspected the stormwater conveyance structures – swales, chutes, and stormwater manholes
  - Also Inspected the leachate manholes
