Guam SOLID WASTE RECEIVER

Briefing for the GSWA Board

February 20, 2025

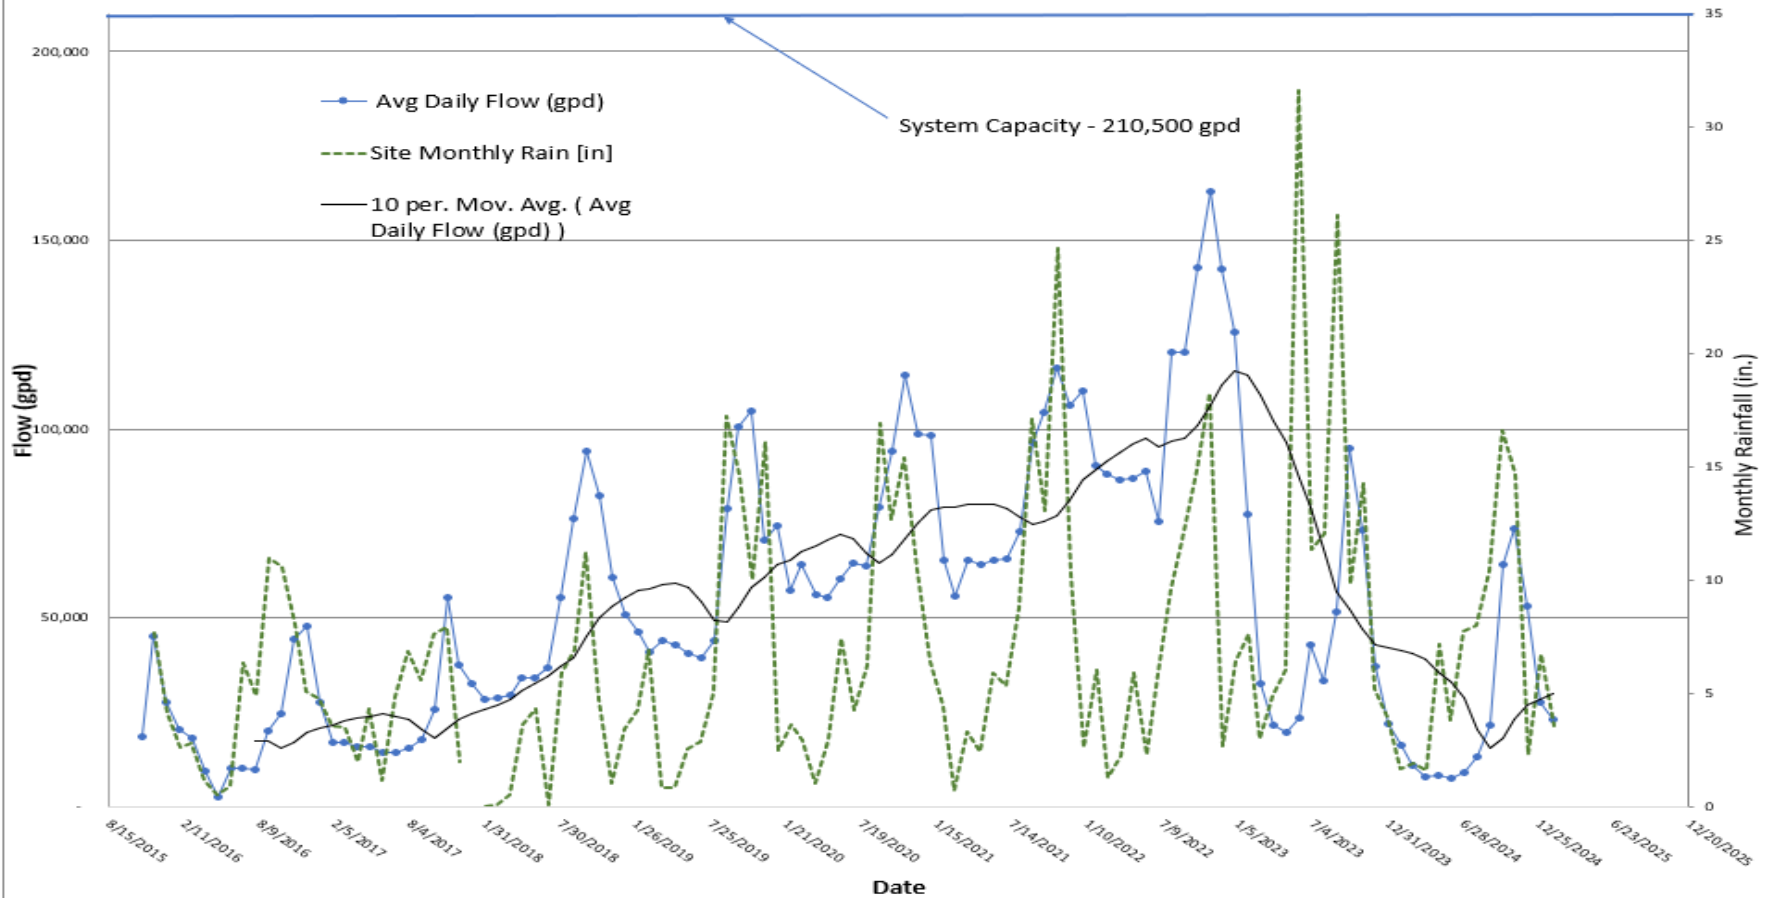
Daily Average Flow and Rainfall by Month Based on GWA Meter

2024 leachate flows now closer to those levels experienced in 2016 and 2017 now that GWA Dero Road leaks no longer impact the Ordot Dump Facility

Year	Leachate (Gallons)
2016	7,397,019
2017	8,518,884
2018	18,658,285
2019	23,952,805
2020	27,748,045
2021	30,040,379
2022 (GWA leaks repaired in December)	40,976,930
2023	15,870,700
2024	9,473,154
2025 (January Only)	713,713 (est)

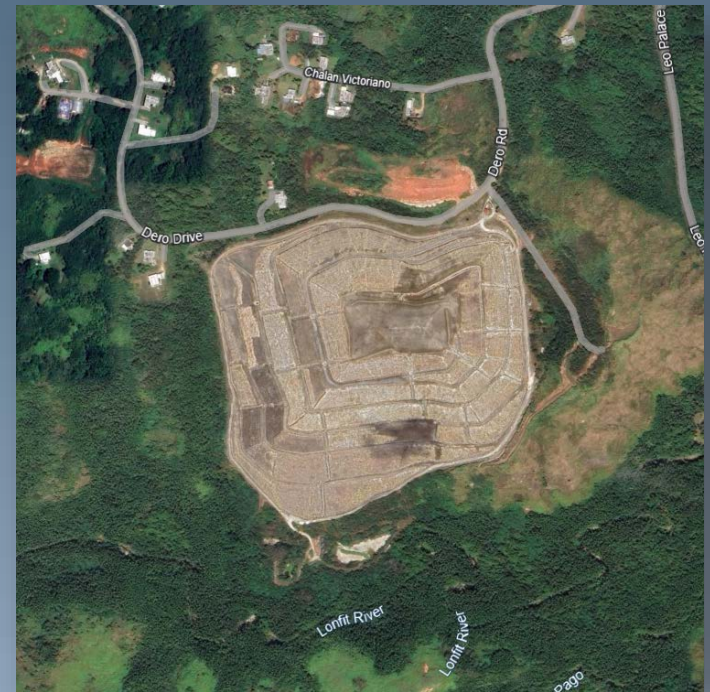
Ordot Dump Post-Closure Facility Ordot, Guam

- Use of this site for disposal goes back to World War II
- Site designated a Superfund site subject to CERCLA and under a Consent Order and Decree
- Unlined dump with waste believed to have been placed on saprolitic soils or the exposed bedrock surface
- Perimeter leachate collection to collect leachate from the waste mass and leachate impacted groundwater
- Modern cover system minimizes infiltration of precipitation into the waste mass

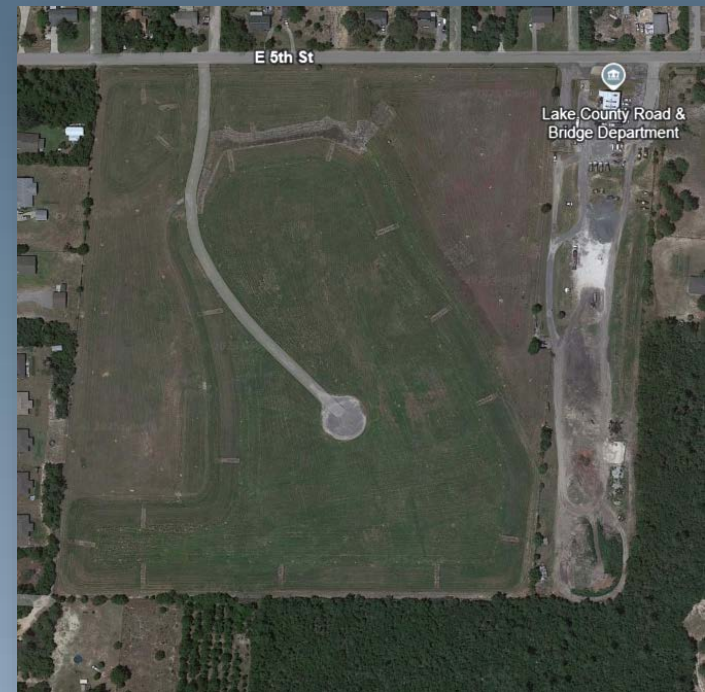
Umatilla Landfill – Lake County Florida (Facility ID No. 19814)

- Unlined landfill with low-permeability soil cover
- No leachate collection system
- Leachate is expected to flow into groundwater
- Unable to determine the impact of precipitation on leachate generation
- Not a Superfund Site

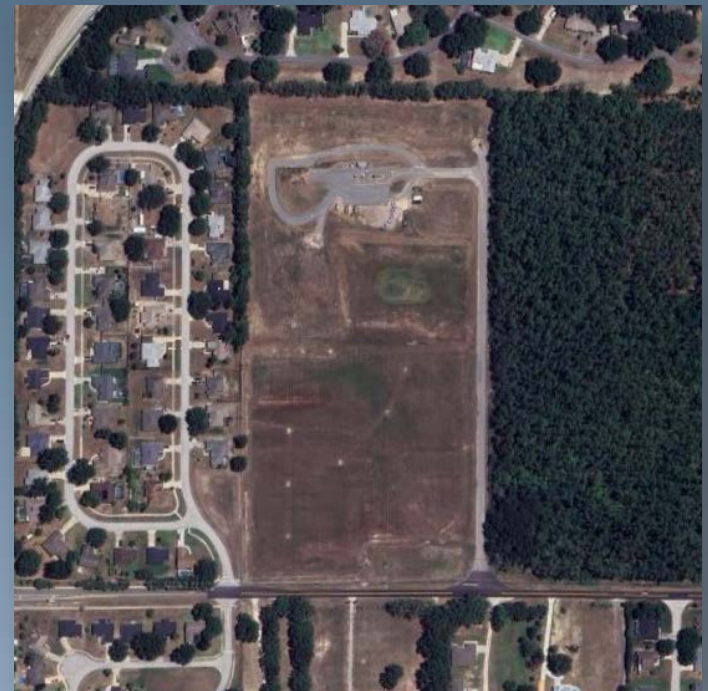
Log House Landfill – Lake County Florida (Facility ID No. 19821)

- Unlined landfill with medium to low permeability soil cover (1-foot)
- Sub-grade soils consist of poorly graded sand with high permeability
- No leachate collection system
- Unable to determine the impact of precipitation on leachate generation
- Not a Superfund Site

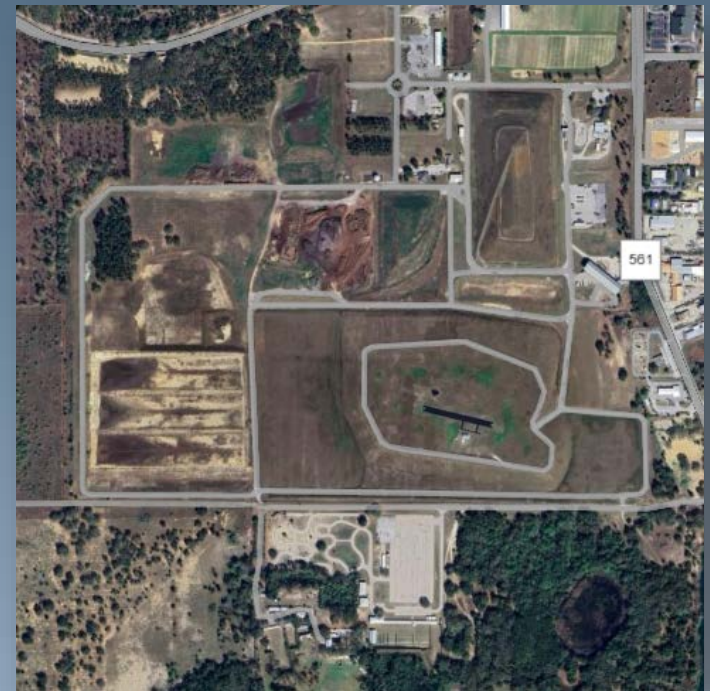
Lake County Central Landfill – Lake County Florida (Facility ID No. 19823)

- Modern landfill with impermeable liner and cover system (like Layon)
- Landfill was closed in 2016
- Liner and cover will prevent infiltration from all directions
- Experienced a leachate spill in 2009 due to heavy precipitation (18.5 inches in May 2009)
- Ordot received over 29 inches during Typhoon Mawar in two days
- Not a Superfund Site

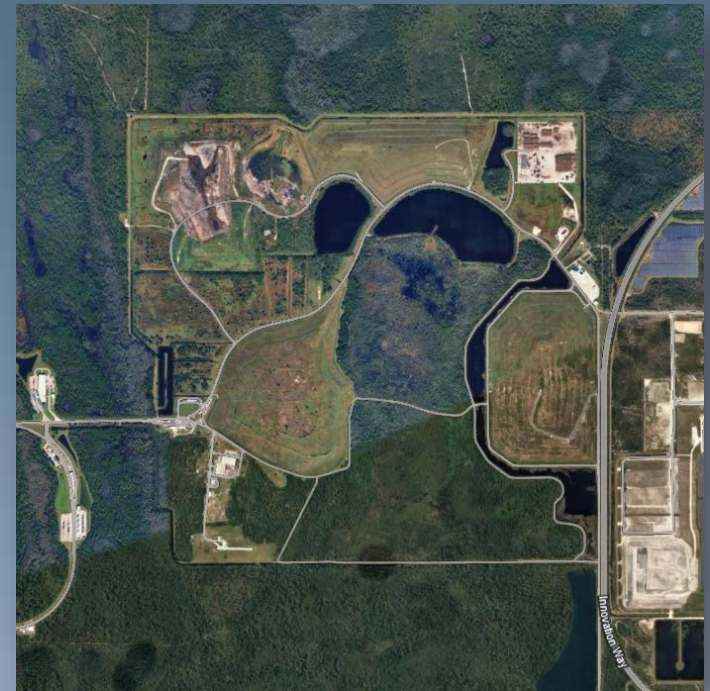
Orange County Landfill – Orange County Florida (Facility ID No. 21847)

- Most cells are developed with modern impermeable liners and cover systems
- Early cells were used by USEPA to study the transmission of leachate and pollutants to shallow groundwater
- Modern liner and cover systems will prevent infiltration from all directions
- In 2022 a leachate spill occurred due to Hurricane Ian
- Not a Superfund Site

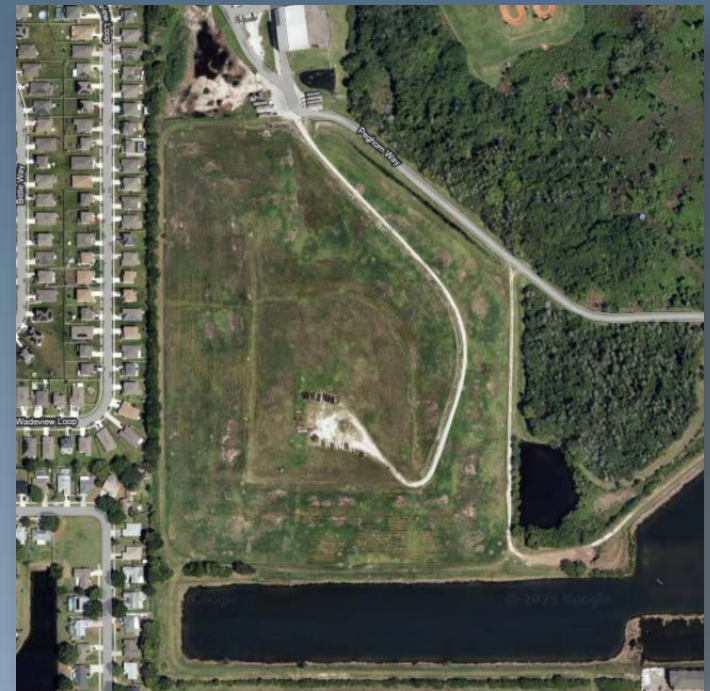
St. Cloud Landfill – Osceola County Florida (Facility ID No. 25469)

- Unlined landfill with a Geosynthetic Clay Liner on side slopes and a 40-mil polyethylene liner on top of the landfill
- A perimeter slurry wall with an interior leachate collection pipe is used to contain leachate
- 2014 Stabilization report shows leachate production correlates with precipitation
- Not a Superfund Site

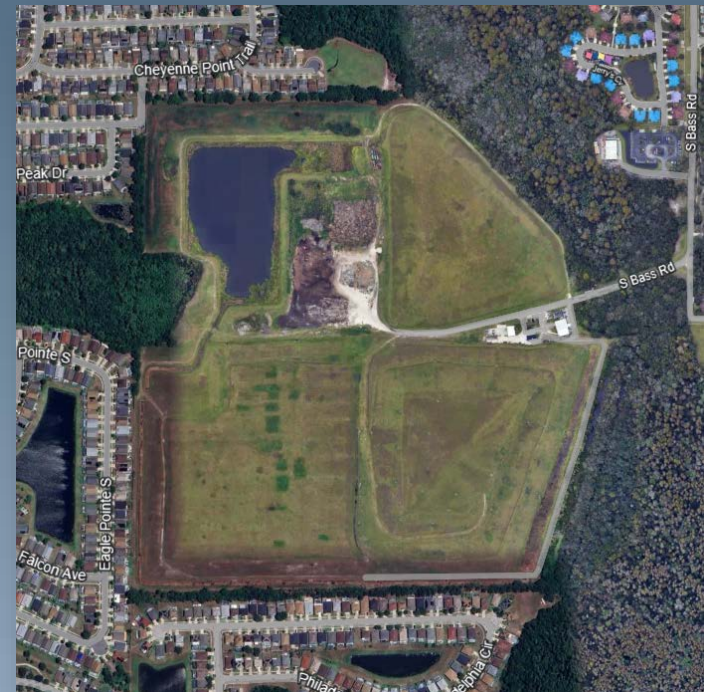
Bass Road Landfill – Osceola County Florida (Facility ID No. 25470)

- Unlined landfill approximately 50 acres in size with a 40-mil polyethylene liner in the composite cover
- There is no leachate monitoring or collection
- The impact of precipitation on leachate production is unknown
- Not a Superfund Site

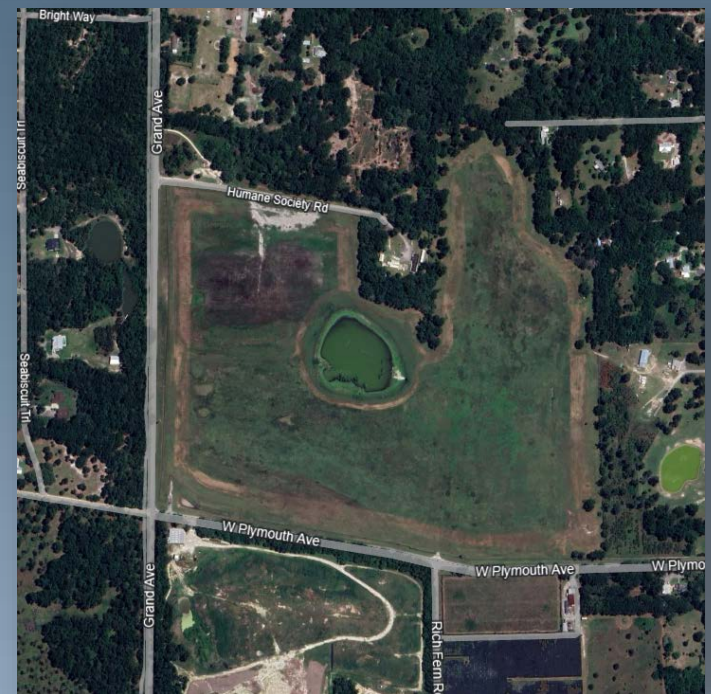
Plymouth Ave Landfill – Volusia County Florida (Facility ID No. 27539)

- Unlined landfill with a geosynthetic clay barrier as a low-permeability cover
- There is no leachate monitoring or collection
- Hydrologic studies show a high vertical flow rate, allowing leachate to migrate to groundwater
- There have been documented migration of contaminants from this landfill
- Not a Superfund Site

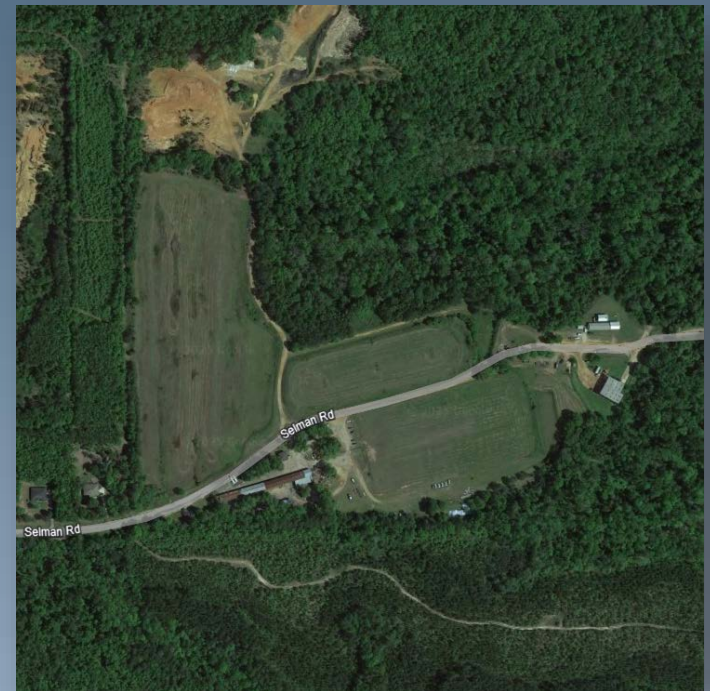
Quincy Byrd Landfill – Gadsden County Florida (Facility ID No. 5729)

- Partially lined landfill with a low-permeability cover system
- Located on soil formations above Quincy Creek
- Post-Closure Care estimates indicate 36,000 gallons per year is collected
- Waste bottom is in the sandy formation, well above bedrock (approx. 30-70 feet)
- Not a Superfund Site
