Status Report

Receivership for the Government of Guam
Guam Solid Waste Authority

Presented by Gershman, Brickner & Bratton, Inc. August 3, 2022

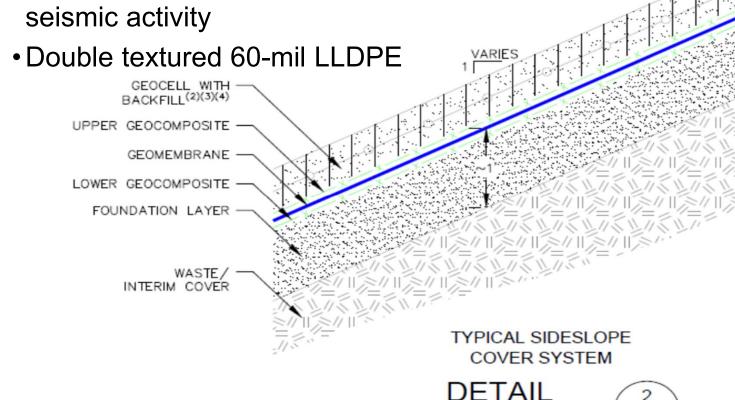
# Ordot Dump Cover (Cap) Design

Geomembrane cover system due to conditions such as steep slopes, tropical climate, typhoons and seismic activity

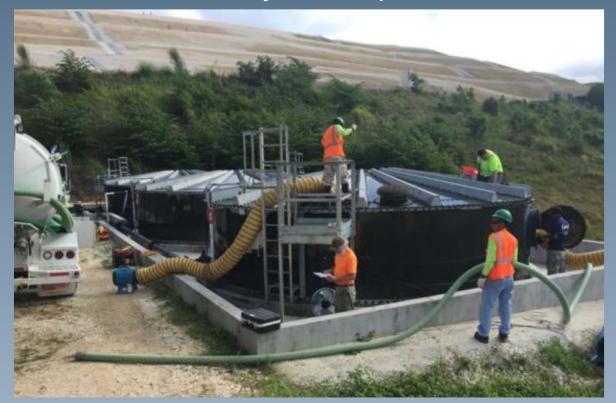
#### Ordot Dump Leachate Collection

- Protects the environment by preventing millions of gallons of leachate from polluting the Lonfit River and ground water
- Leachate meets GWA system requirements for treatment

- Leachate discharged to GWA Hagåtña Wastewater Treatment Plant for treatment
- Leachate system began to discharge collected leachate in January 2015
- Quarterly technical memos on leachate quality and volume
- Data in technical reports include
  - Chemical oxygen demand
  - Total Kjeldahl nitrogen
  - Alkalinity
  - Ammonia
  - Nitrate
  - total dissolved solids
  - TSS

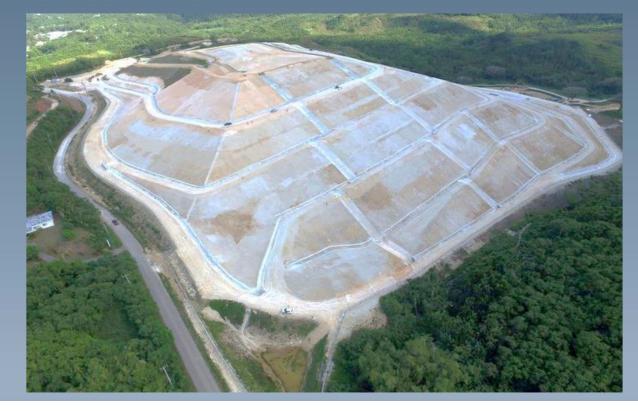
# Ordot Dump Cover System Swale

- Stormwater Swales and Chutes
  - Channels to collect and convey stormwater runoff
- Quarterly reports
- NPDES MSGP for Closed Landfill site

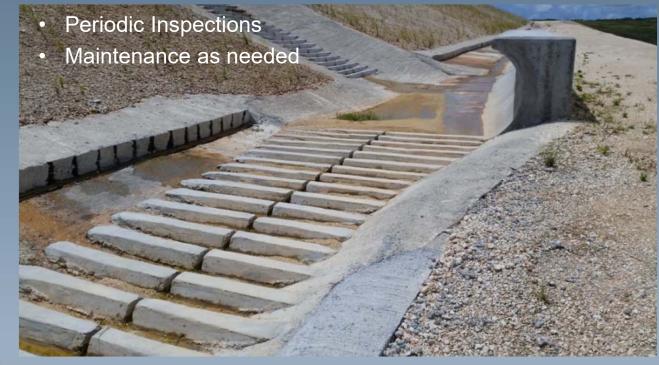
# Ordot Dump Surface/Storm Water Management

- System collects stormwater and conveys it of the cover system to 4 detention ponds for control of peak flows allowing it to return to the environment without impact
- Regular Post Rainstorm inspections
- Post-closure work includes:

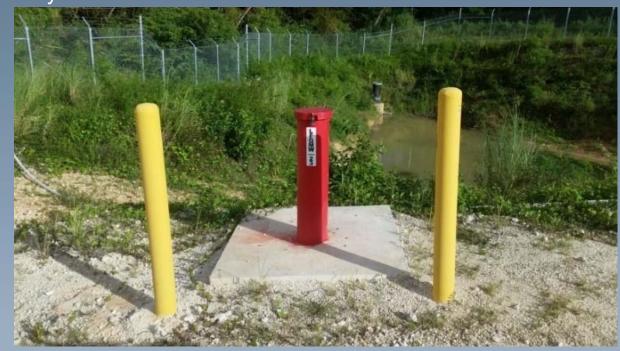
# Ordot Dump Monitoring Wells

- Gas Collection and Control System
   Protects the environment by collecting and treating millions of cubic feet of greenhouse gases
- Perimeter monitoring
   Network of monitoring wells detect landfill gas, if any, along the perimeter of the cover system
