Route 4 (Route 10 to MSWLF Turnoff)

Layon Landfill Haul Route Improvements

Status Report on Bridges and Roads Repair/Renovations

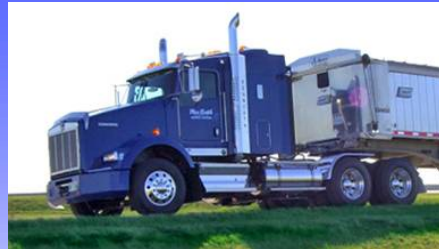
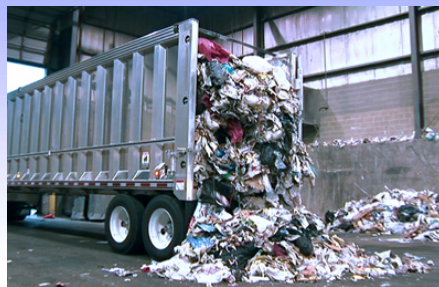
- **Vehicle used for analysis**
 - Kenworth T800 Tractor
 - 45 foot Long Mac Transfer Trailer
 - 40 foot centerline tractor axle to centerline trailer axle
 - 102" max trailer width
 - Approximately 13 hauls per day
 - Type 3S2 36 Tons
- **Confirmed with local solid waste collection company (Mr. Rubbishman) that 45 ft long Mac Transfer Trailers will be used**

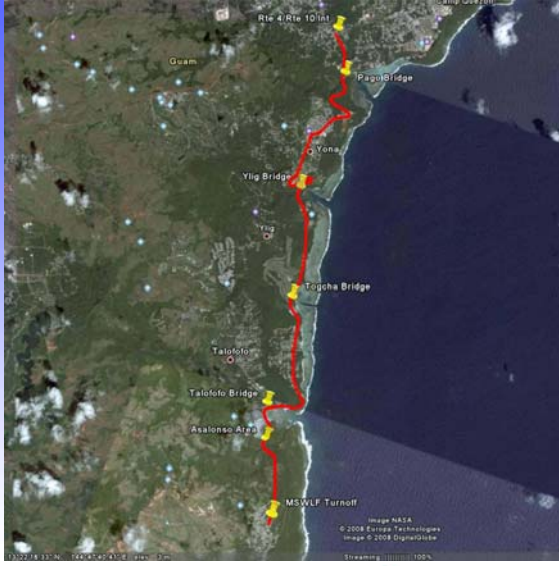
- **Route Features**
 - Pago Bridge
 - Ylig Bridge
 - Togcha Bridge
 - Talofoto Bridge
 - Asalonso Area
 - 11 Route Miles
 - 2 lane to 4 lane roads
 - Speed limit varies from 25 mph to 35 mph

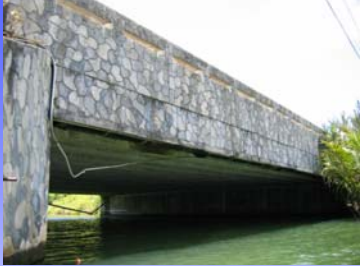
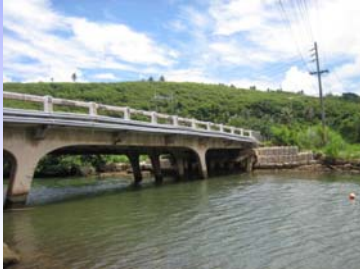
- **Pago Bridge**
 - Single Span Girder Bridge
 - 70 ft Long & 69 ft Wide
 - Constructed in 1984
 - Load Rating per FHWA 2004 Inspection Reports
 - Type 3S2 45 Tons (Normal Traffic)
 - Type 3S2 75 Tons (Maximum Load)
- **Ylig Bridge**
 - Three Span Beam Bridge
 - 144 ft Long & 33 ft Wide
 - Constructed in 1968
 - Load Rating per FHWA 2004 Inspection Reports
 - Type 3S2 10 Tons (Normal Traffic)
 - Type 3S2 16 Tons (Maximum Load)

- **Route 4 Improvements**
 - Based on transfer truck length, roadway geometry improvements required on Northern segment of Route 4
 - Ylig bridge has insufficient load carry capacity and needs to be replaced
 - Roadway embankment stabilization and channel slope protection required at Asalonso area to prevent failure of roadway
- **Analyzed improvements, but deemed unnecessary**
 - Climbing lanes for stretches of road north and south of Talofoto and Asalonso area
 - Posted speed limit is 25 mph & trips required by the transfer trucks do not warrant the addition of climbing lanes.
 - Pago, Togcha and Talofoto bridges have sufficient load carrying capacity. Upcoming inspections will reassess these structures and determine required repairs if necessary.

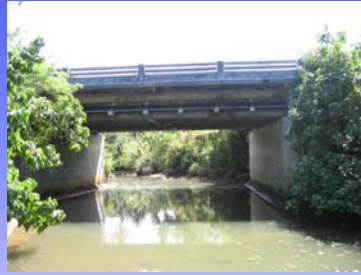
• Togcha Bridge

- Single Span Tee Beam Bridge
- 46 ft Long & 46 ft Wide
- Constructed in 1972
- Load Rating per FHWA 2004
- Inspection Reports
 - Type 3S2 51 Tons (Normal Traffic)
 - Type 3S2 86 Tons (Maximum Load)

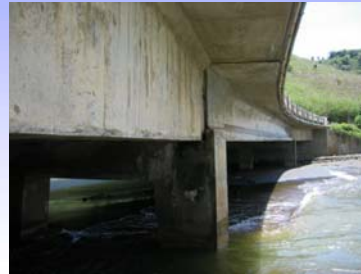
• Talofoto Bridge

- Three Span Girder/Beam Bridge
- 160 ft Long & 38 ft Wide
- Constructed in 1979
- Load Rating per FHWA 2004 Inspection Reports
 - Type 3S2 41 Tons (Normal Traffic)
 - Type 3S2 69 Tons (Maximum Load)

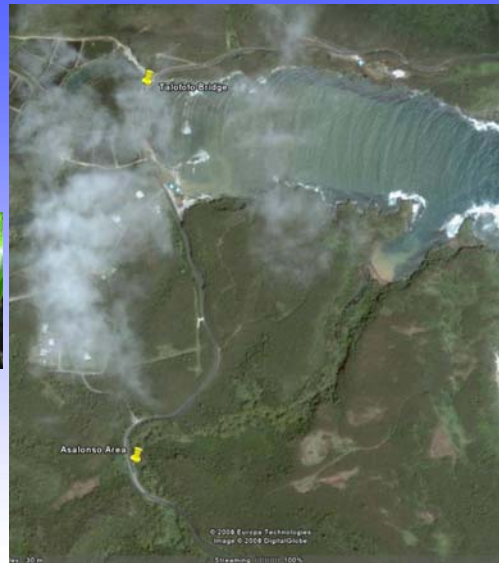
• Asalonso Area

- Typhoon Damage
- Earthquake Damage
- Roadway & Embankment Repair
- Channel Bank Restoration/Protection

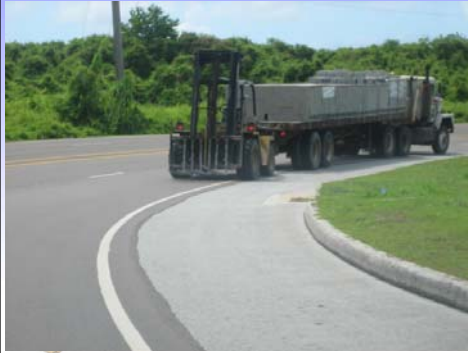
- **Roadway Horizontal Geometry**
 - Widening at curves to prevent off-tracking
 - Widening to provide shy distance to guardrail
